This detail exhibits rebuild strategies with extruded architectural terra cotta (TC). Other options may be appropriate. It is best to consult a professional team of engineers, architects, and architectural conservators when crafting a repair or rebuild scenario for historic architectural TC.

Sill and mullion rebuild | Terra cotta, extruded

10.030.0433

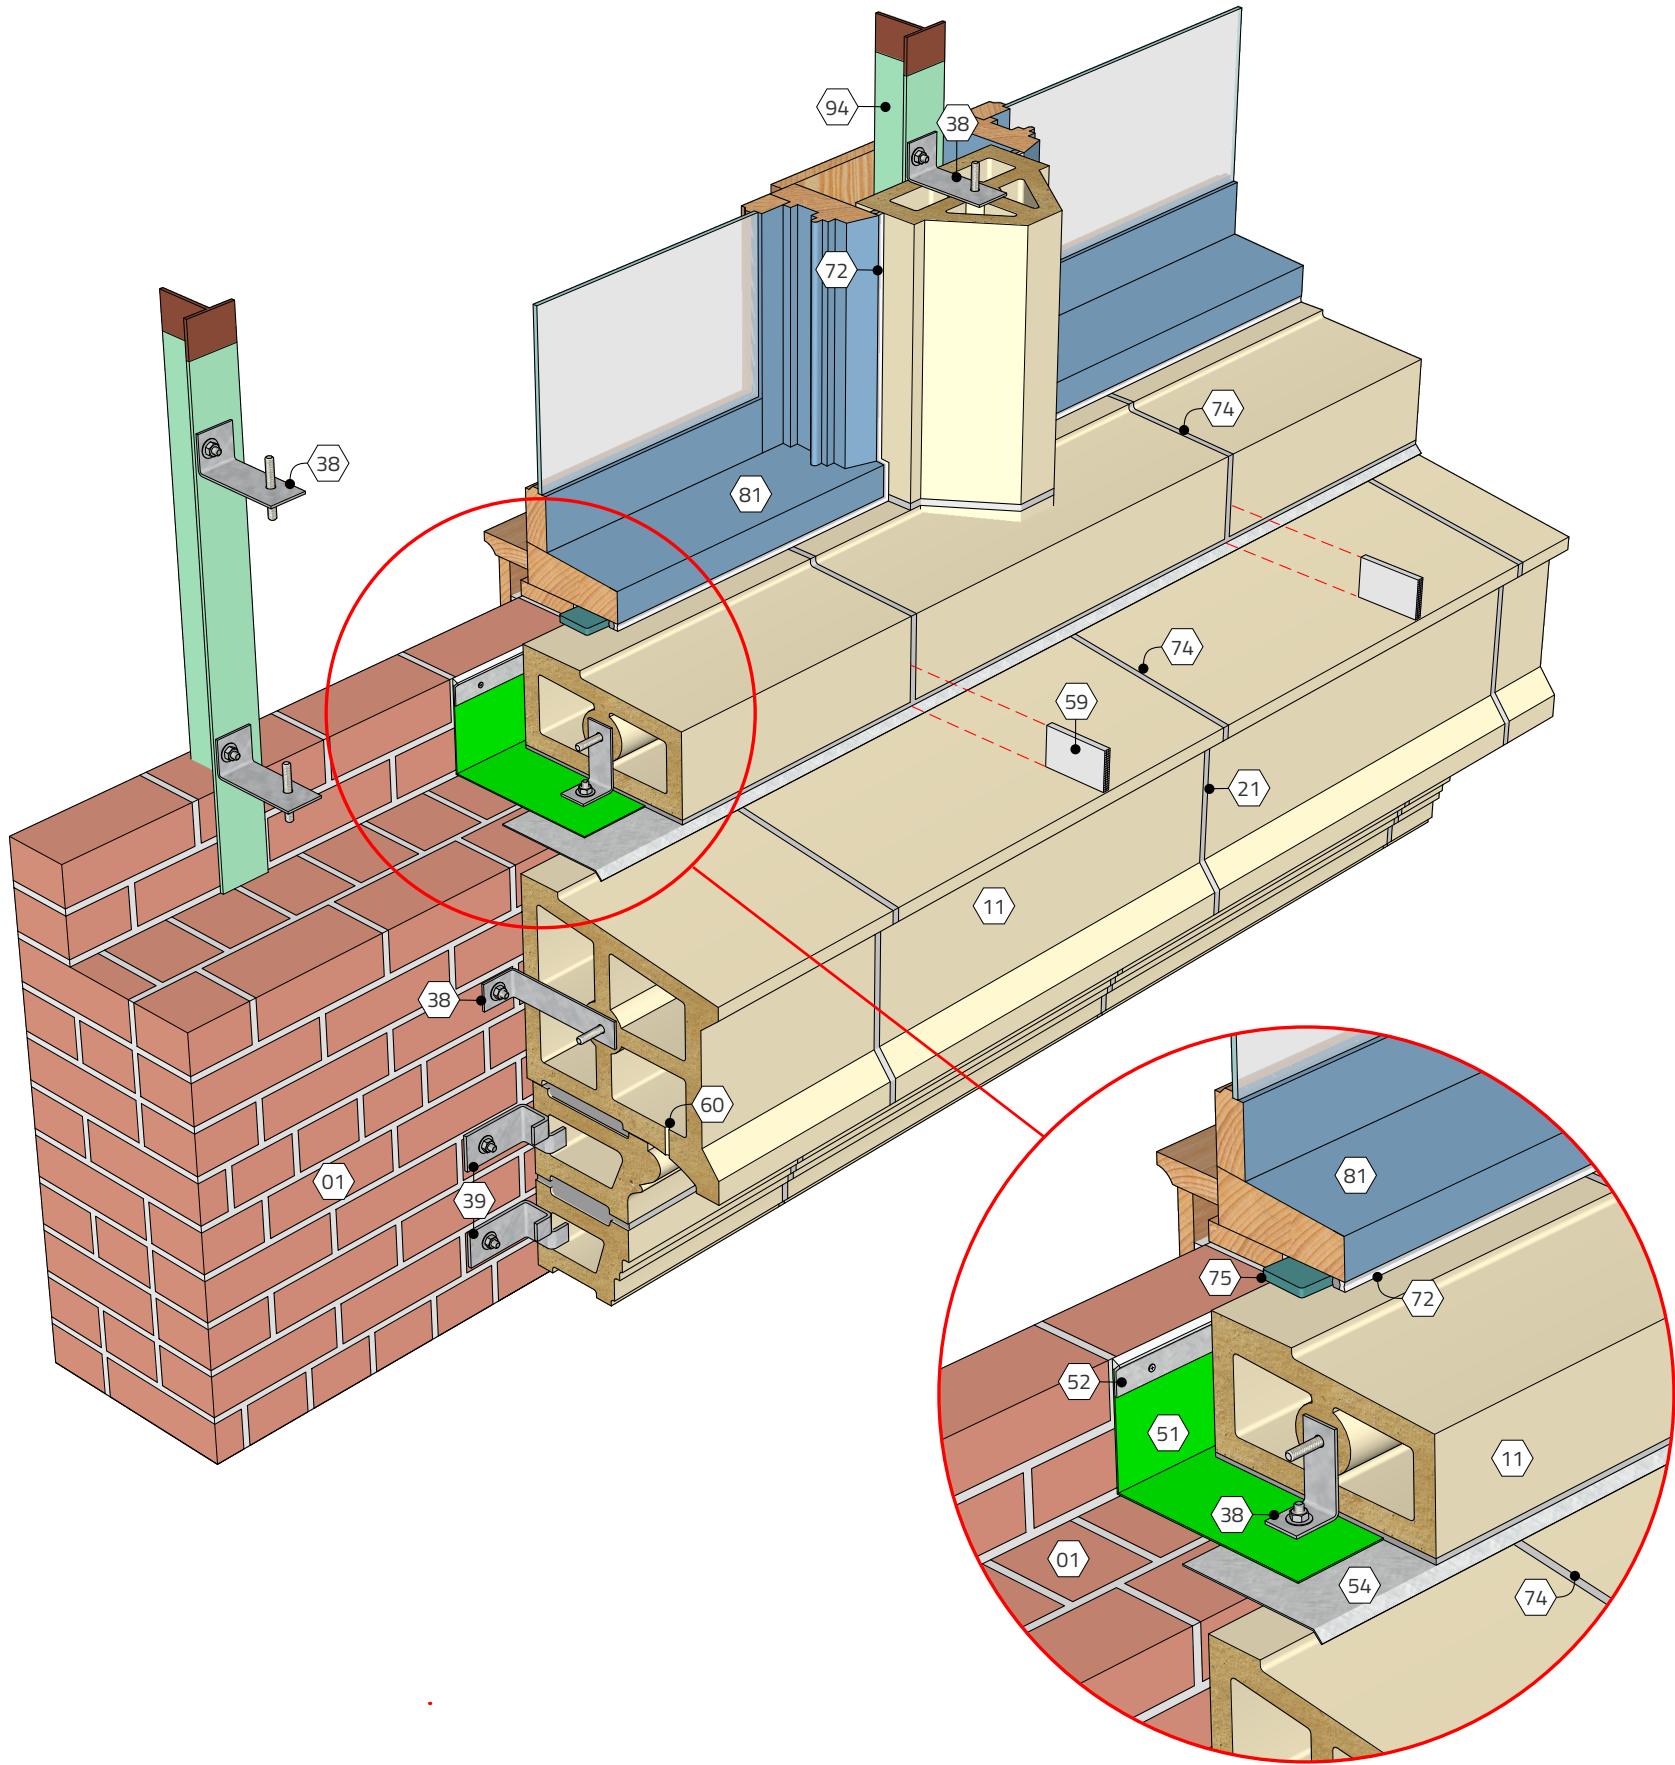
- 01 (E) Masonry backup, multiwythe construction
- 11 Architectural terra cotta, extruded
- 21 Mortar
- 38 Stainless steel strap and pin anchor
- 39 Stainless steel split tail anchor
- 51 Flashing system with end dams as required
- 52 Termination bar with continuous sealant
- 54 Stainless steel drip edge; seal and adhere to substrate
- 59 Weep vent
- 60 Weep hole at underside of each overhanging TC unit
- 72 Sealant and backer rod
- 74 Sealant or lead T-caps at all horizontal skyward-facing joints
- 75 Plastic setting shims as required
- 81 (E) Window assembly
- 94 (E) Structural steel treated with corrosion-inhibiting coating

This drawing references Sill and Mullion - Original Plate 32.

Anchors to be located at end of TC units; shown at cut unit for clarity.
