Number 15

LOYOLA UNIVERSITY CHICAGO LEWIS TOWERS East Elevation - Chicago, IL

DESCRIPTION: Renovation of the exterior facade of a 1926 Neo-Gothic high-rise requiring extensive repair & replacement of glazed terra cotta, face brick, steel shelf angles and lintels.

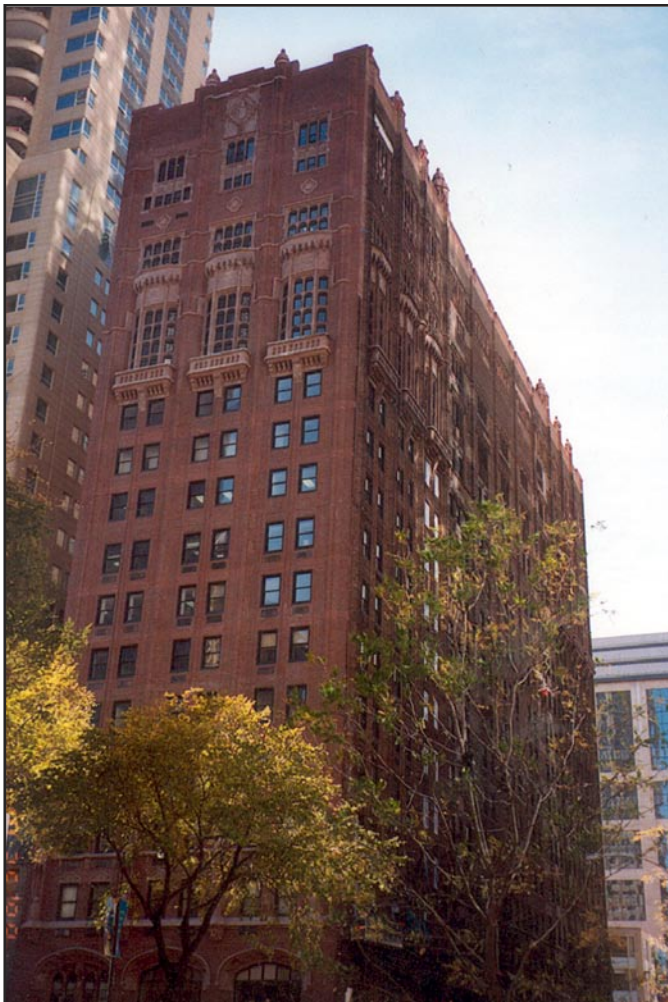
Lewis Towers is an 18-story high-rise built in 1926 and located on the prestigious north end of Chicago's Michigan Avenue. The facade of the Neo-Gothic style building is primarily composed of dark reddish-brown coarsely textured face brick. The trim on the lower stories and the highly decorative Gothic ornamentation on the three bays of the upper stories dividing the east elevation, is

composed of a light beige glazed architectural terra cotta. Rectangular in shape, the building measures 224' x 60' with a height of 210'.

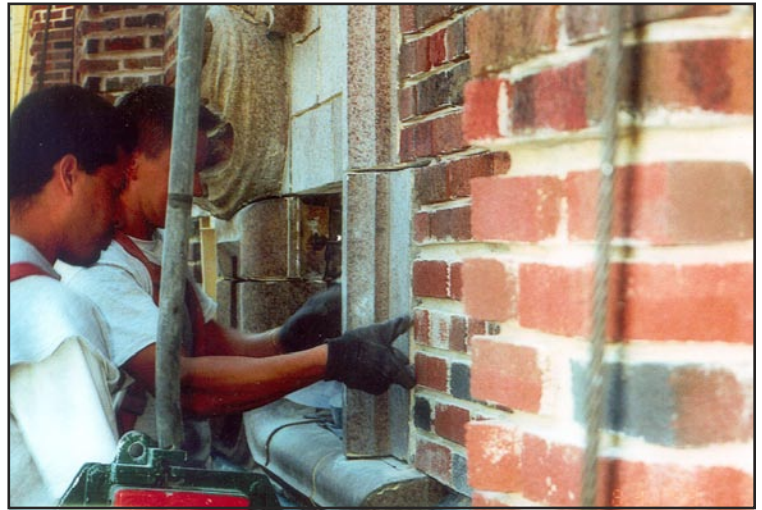
Approximately 200 separate terra cotta pieces in 19 different profiles, shapes and sizes were replaced. Approximately 10,000 individual face bricks were also removed and replaced.

The quantity of terra cotta to be replaced was determined by carefully performing a thorough survey of each individual piece. Ultimately, over 200 separate terra cotta pieces in 19 different profiles, shapes, and sizes were replaced, either because of severe damage, or because access was needed to the structural steel supporting them.

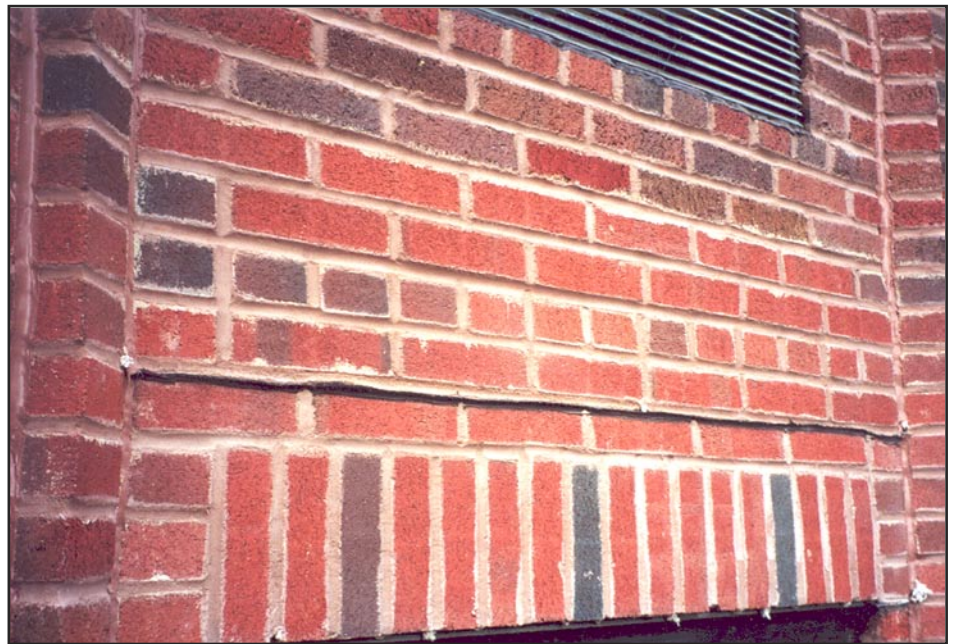
Removal of a minimum of five brick courses both above and below the existing steel shelf angles was required ... The new face brick had to be carefully matched to the existing masonry in size, texture and, more importantly, its original “clean” color.

Restoration of steel shelf angles required the removal of a minimum of five brick courses both above and below the existing angles, which extended the entire width of the facade at each of the 18 floor lines. This portion of the work was particularly demanding because of the special attention required by the three-sided pilasters and two-sided piers extending the 18 stories at various locations throughout the

facade. The process included the setting of new masonry at 45-degree angles to match existing coursing and design, and the application of water management details in the form of polyurethane membrane flashing and rope weeps.

Approximately 10,000 individual face bricks were removed and replaced with new ones supplied by Beck-Ramm Brick Co. In addition, a small percentage of existing bricks were meticulously restored to their original condition and reinstalled at key locations. As with the terra cotta, the face brick had to be carefully matched to the existing masonry, not only in size and texture, but also, and more importantly, to its original “clean” color. Areas where previous masonry work had been performed required staining to re-establish original color.
